FLIR APPLICATION STORY

Infrared thermography for on-orbit space shuttle maintenance : NASA uses modified FLIR Systems ThermaCAM S65 infrared camera for inspection of Discovery spacecraft

The NASA Langley Research Center has chosen ThermaCAM S65 as the preferred infrared camera system for its shuttle and International Space Station programs. The modified camera system was successfully used during the July 2006 STS-121 Discovery mission.

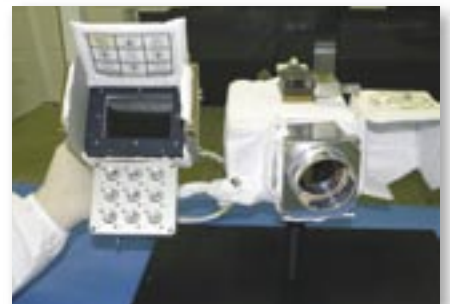
The protective housing for the ThermaCAM S65 as developed by NASA

the ThermoCAM S65 into space-hardened EVA (Extra Vehicular Activity) flight hardware. These modifications would enable the camera to stand mechanical kick load, cosmic and intense sun radiation, fire hazard, shock, vibration, electromagnetic compatibility and severe temperature requirements. Moreover, the crew had to be provided with a camera which could operate on a space-certified battery pack, and which could be used with big gloves during spacewalk inspection rounds in a zero gravity environment.

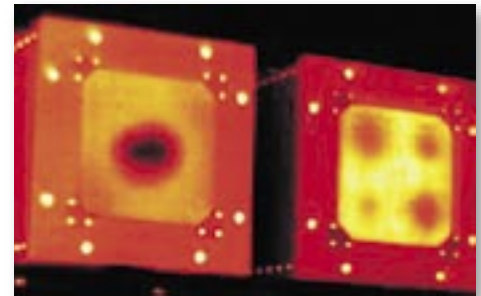
Unprocessed image of the damaged RCC samples. The internal damage (left) is clearly visible

Three spacewalks were scheduled for STS-121. The third was intended to test orbiter heat shield repair techniques. The cargo bay of the Discovery contained a sample box with an array of 10 pre-damaged Reinforced Carbon-Carbon (RCC) samples. These samples were used to test new adhesive repair techniques, but they were also imaged by the EVA IR camera. The astronauts also used the camera, which was attached to their spacewalk tool belt, to scan the wing leading edge of the shuttle and the radiators of the ISS. Sellers and Fossum held the detached LCD display in their hands to scan the objects in infrared, as many ThermoCAM S65 users also prefer to do.

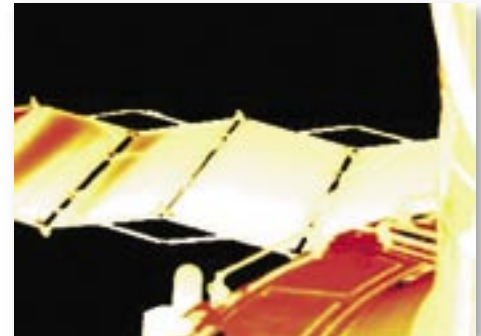
Unprocessed IR image of one of the ISS radiators
